Manhole Inspection Summary

Manhole # S37II_001MH

Insp Date: **3/16/07 11:33 AM**

Location Address: **402 LANVALE ST**

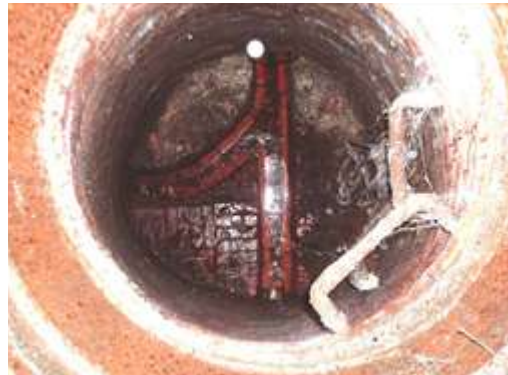
Top View

Corroded steps. Evidence of surcharge - Bench debris.

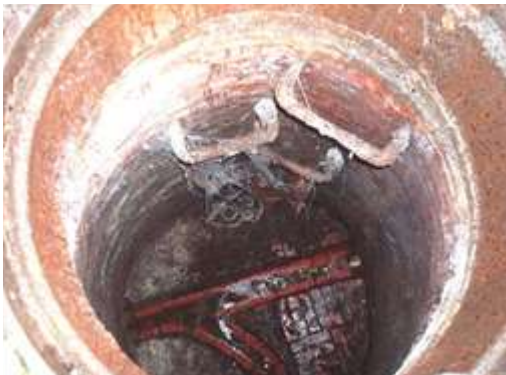
Defect

Adjustment deterioration and infiltration. Corbel and Barrel infiltration.

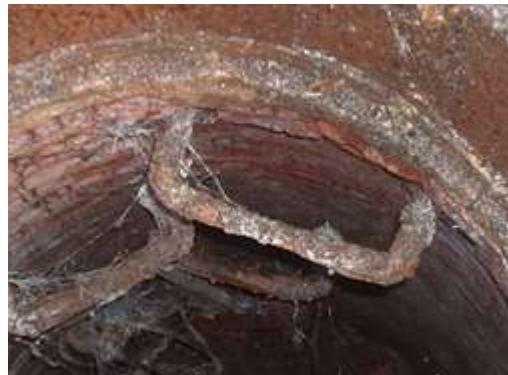
Defect

Adjustment deterioration and infiltration. Corbel infiltration.

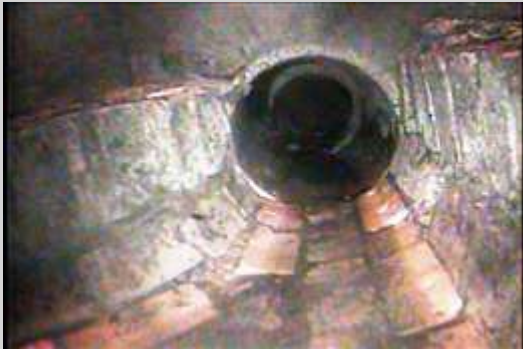
8 in. Circular Gravity Sewer Pipe Out @ 12 O'Clock

Invert Depth: **8.95** (ft.) Flow Characteristics: **Slow**

Deposits: ☒ None ☐ Mud ☐ Sludge ☐ Debris ☐ Grease

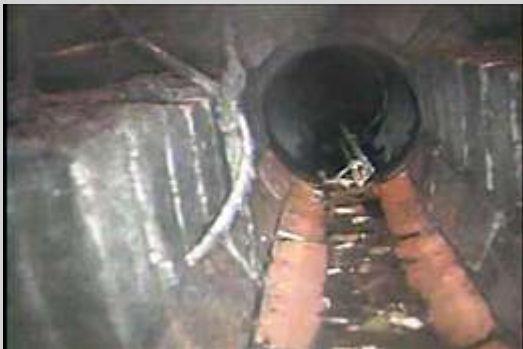
8 in. Circular Gravity Sewer Pipe In @ 6 O'Clock

Deposits: ☐ None ☐ Mud ☐ Sludge ☒ Debris ☐ Grease

Silt Depth: **0** (in.) Deposits Extent: **Light**

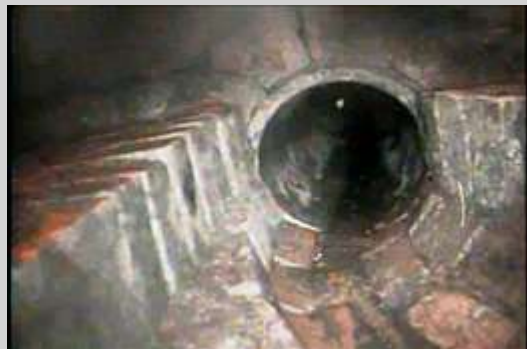
Pipe In @ 9 O'Clock

Deposits: ☐ None ☐ Mud ☐ Sludge ☐ Debris ☒ **Grease**

Deposits Extent: **Light**
